## Home Inspection Report

3453 Brevard Rd, Mims, FL 32754  
Inspection prepared for: Melissa Lorange  
Date of Inspection: 7/13/2022  
Age of Home: 1989

Inspector: Ryan Mayer  
License # HI11755  
Email: [info@surehomes.org](mailto:info@surehomes.org)

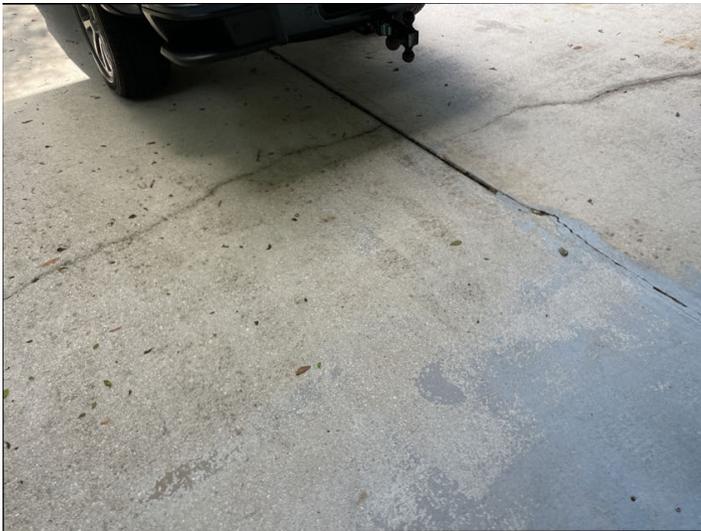
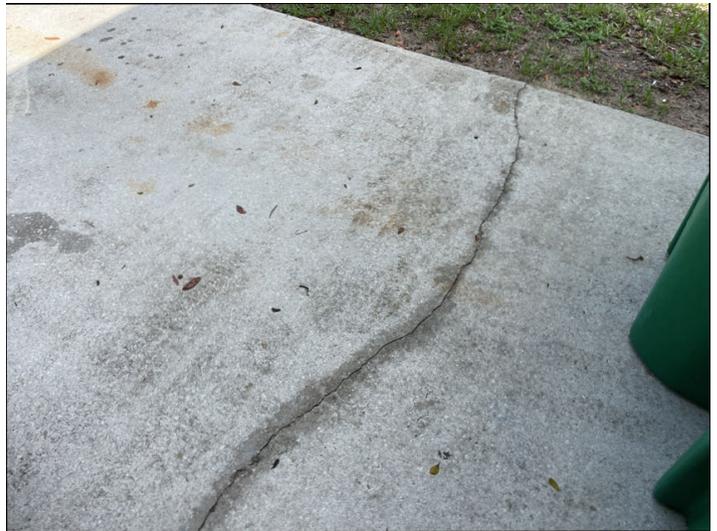
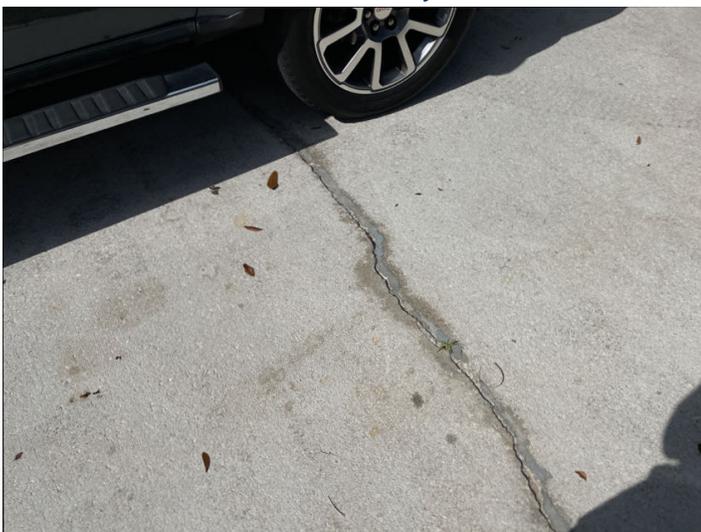
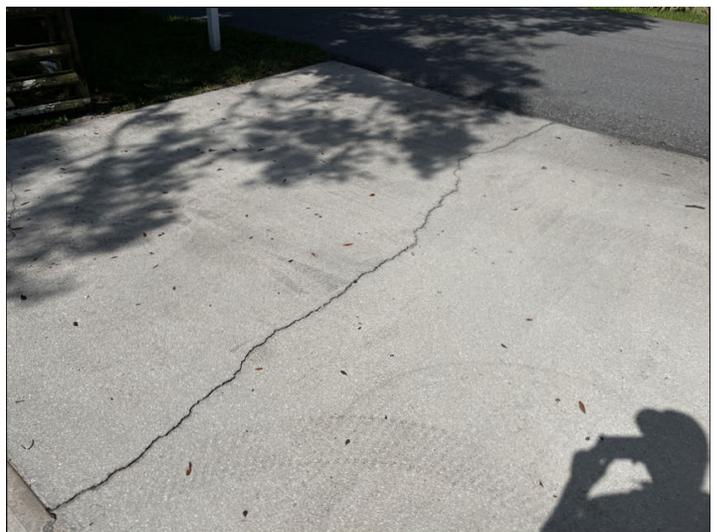
- Moderate cracks in driveway. Repair and/or monitor for expansion and development of trip hazards.

Moderate Driveway Cracks

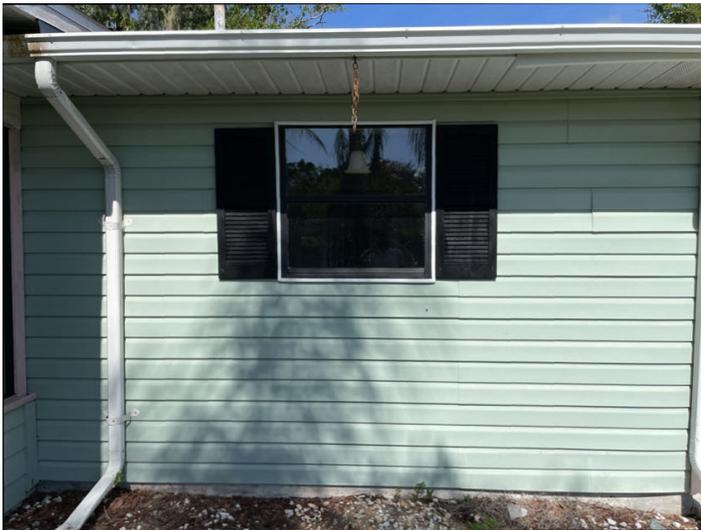
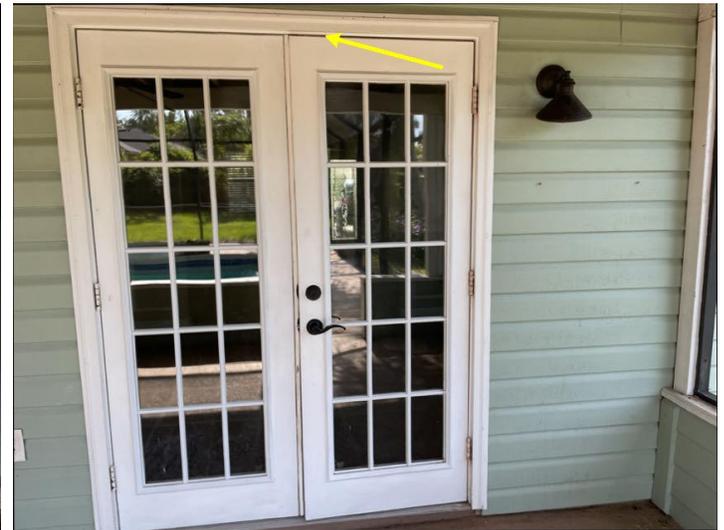
Door Out of Alignment

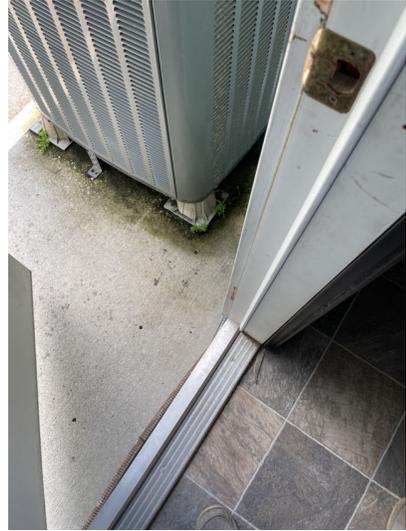
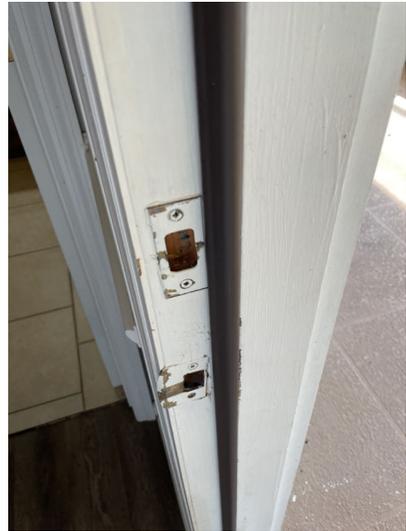
- All exterior doors appeared in functional and satisfactory condition at the time of inspection.
- French doors do not lock on deadbolt. Needs adjustment. Door is also lower on right side.

French Door Won't Lock

Alignment Issue

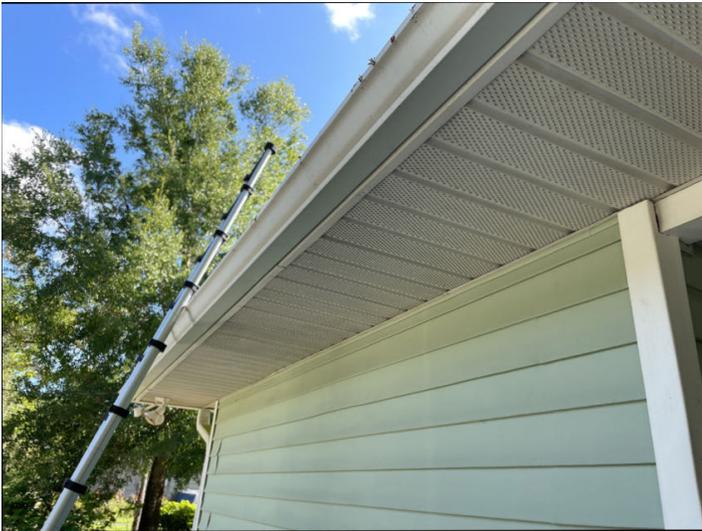
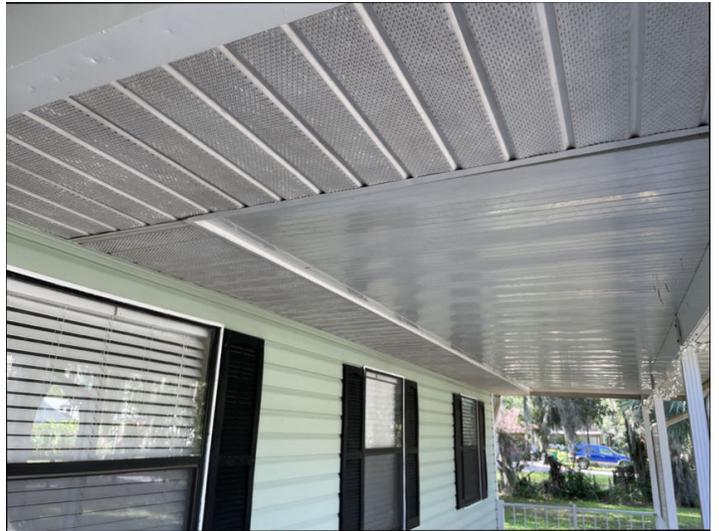
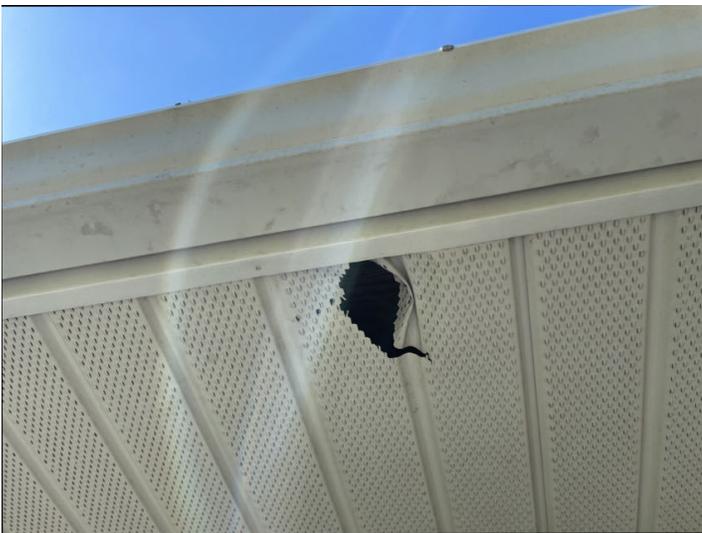
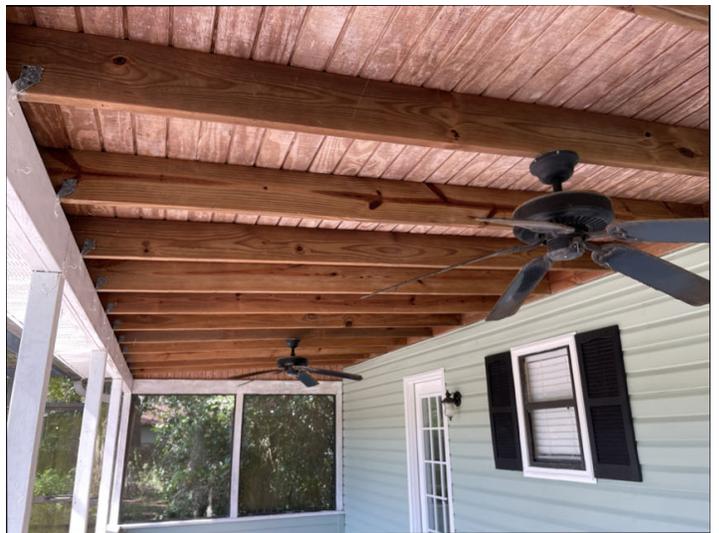
- Soffits missing, loose or detached. Suggest repair or replacement.

Open Soffit

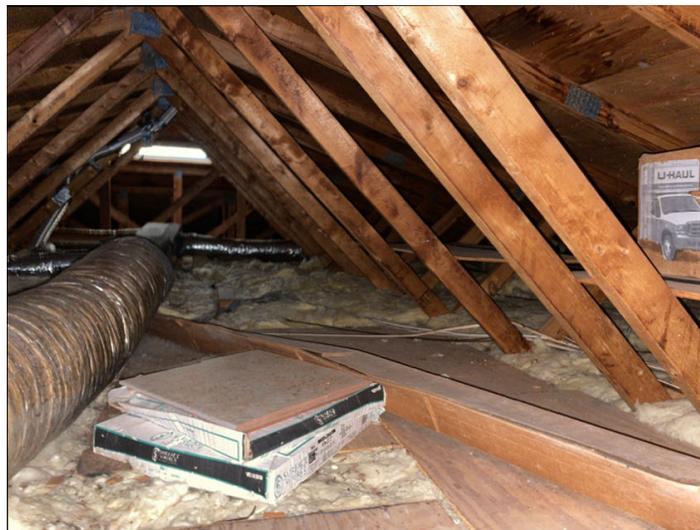
Depth of Insulation: Insulation averages 3 to 4 inches. Recommend installing more.

- Insulation appears to have settled significantly, which will not perform to its original R-Value. Expect higher energy loss and heating & cooling costs. Recommend an insulation contractor evaluate for replacement and/or addition.

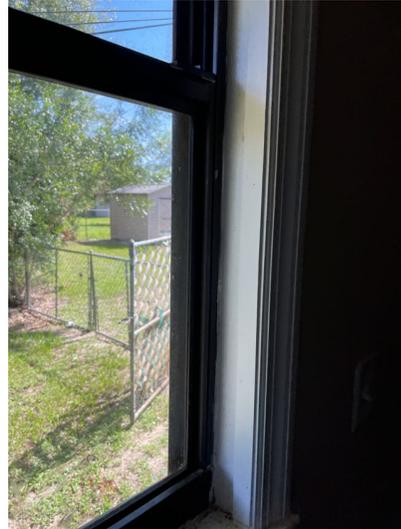
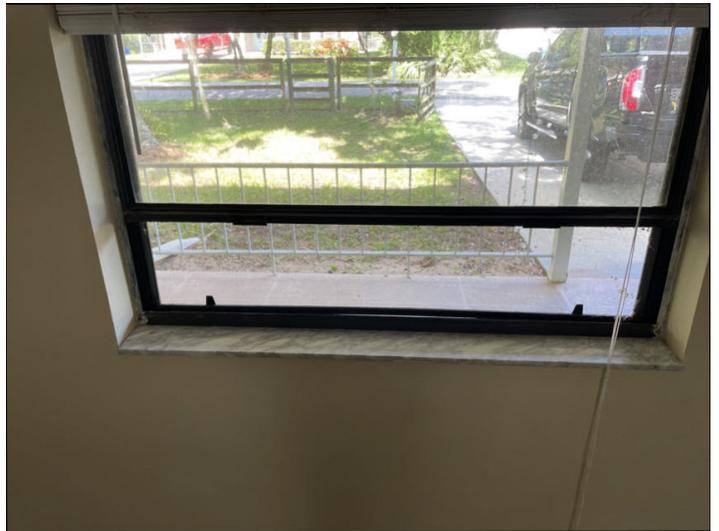
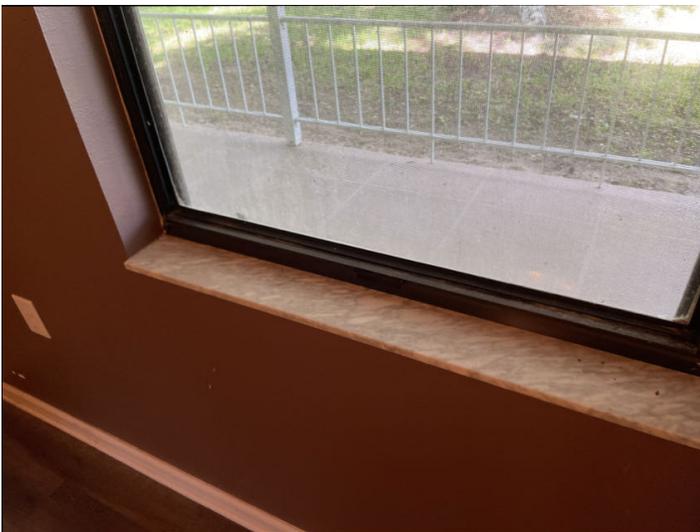
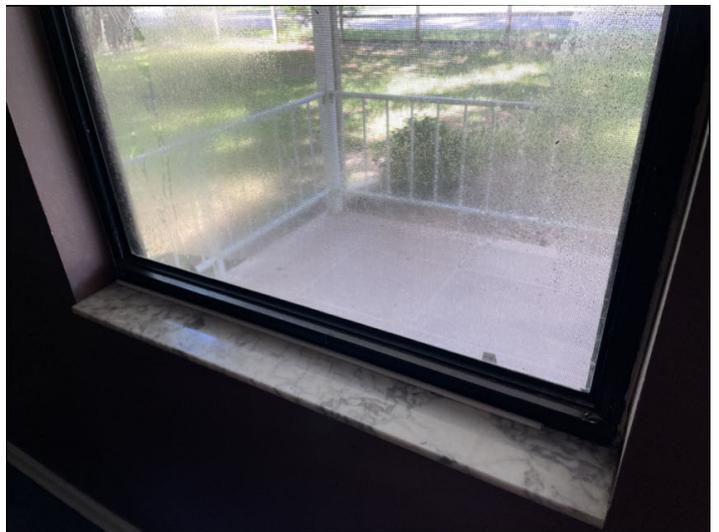
Possible Seal Broke in Window - Condensate

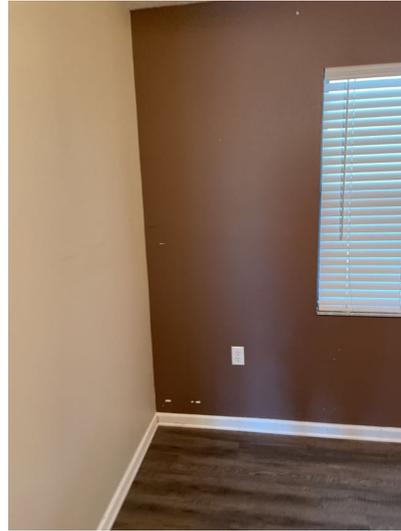
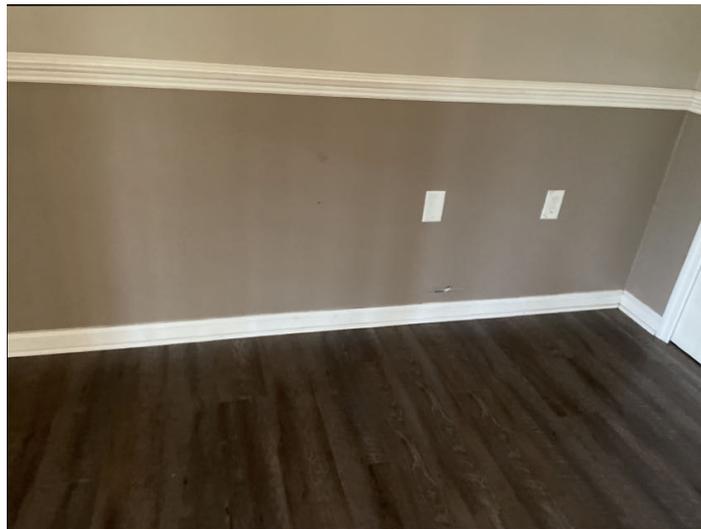
- Wall finish, paint and baseboards appeared to be in serviceable condition at time of inspection.
- Evidence of prior drywall repair. Recommend recoating by drywall professional.

Minor Drywall Damage

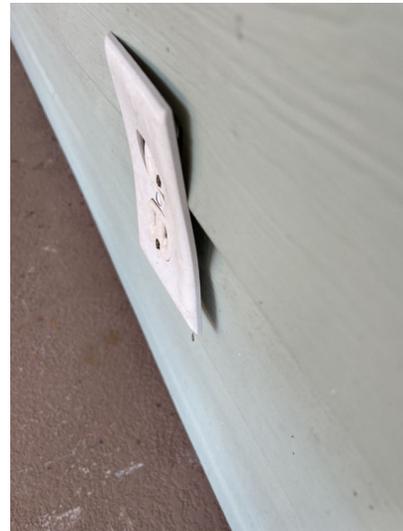
- No exterior electrical outlet issues noted at the time of inspection.
- Receptacle loose in box. Recommend repair for safety.

Loose Receptacle Outside
