## Home Inspection Report

3453 Brevard Rd, Mims, FL 32754  
Inspection prepared for: Melissa Lorange  
Date of Inspection: 7/13/2022  
Age of Home: 1989

Inspector: Ryan Mayer  
License # HI11755  
Email: [info@surehomes.org](mailto:info@surehomes.org)

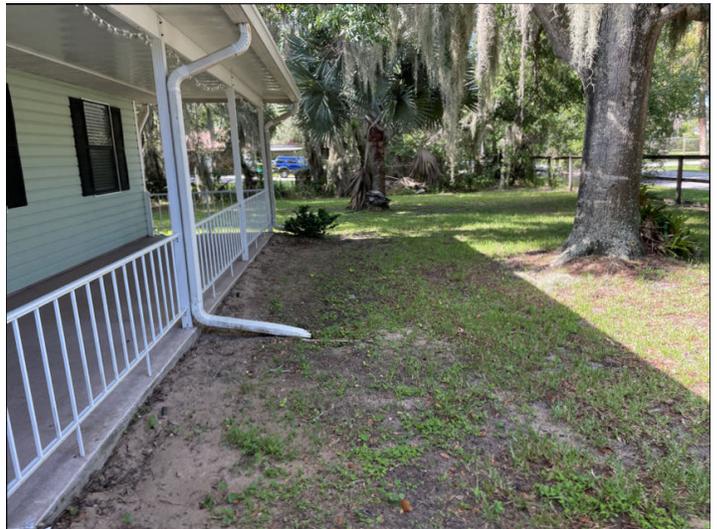
- Plants or bushes in contact with or close proximity to home should be trimmed to eliminate pathways for insects.

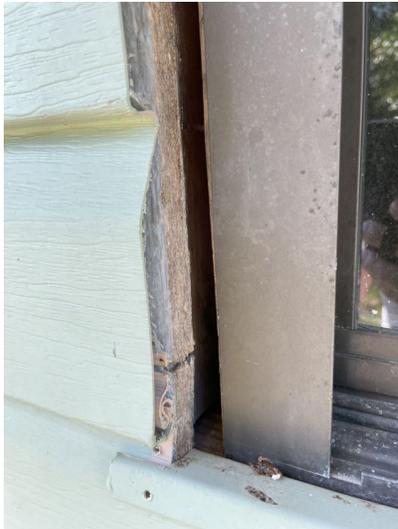
Window Not Properly Sealed

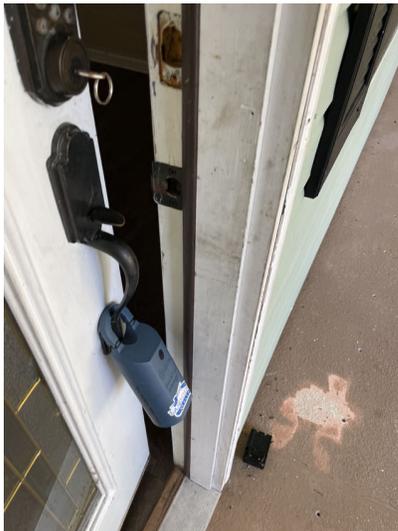
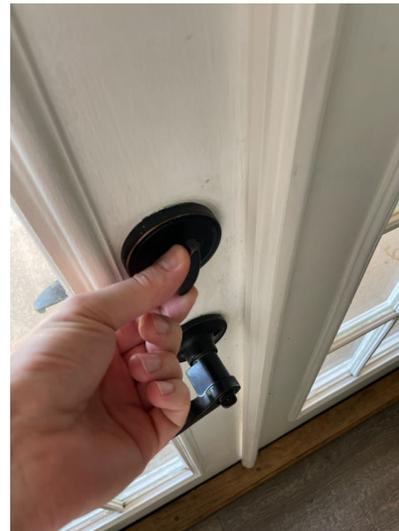
- All exterior doors appeared in functional and satisfactory condition at the time of inspection.
- French doors do not lock on deadbolt. Needs adjustment. Door is also lower on right side.

French Door Won't Lock

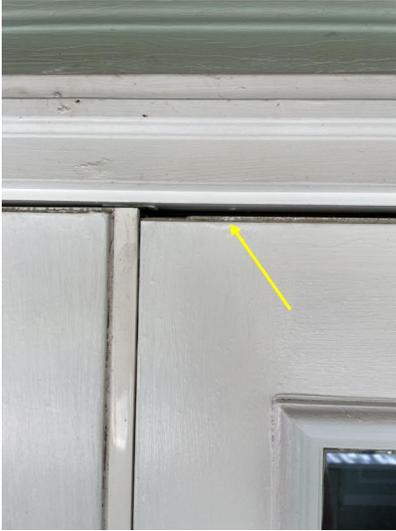
Alignment Issue

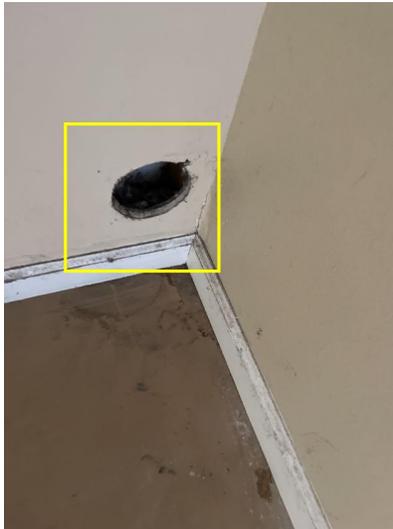
- Vent male adapter missing.

Missing Fitting

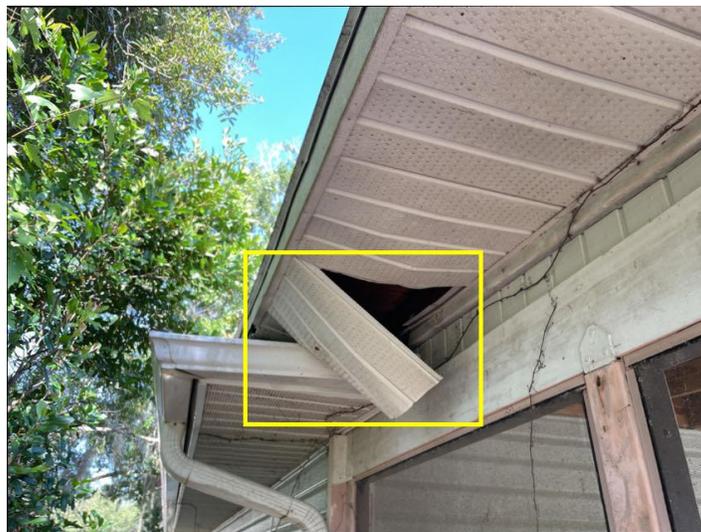
- Soffits missing, loose or detached. Suggest repair or replacement.

Open Soffit

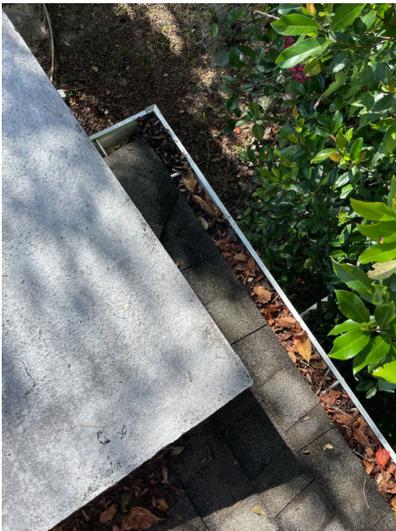
- Downspouts missing from gutters; recommend installation to keep water off siding.
- Significant amounts of debris evident in gutters. Recommend regular cleaning.

Heavy Debris Gutters

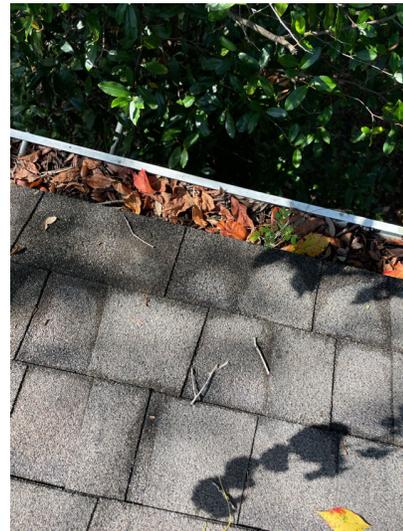
Heavy Debris Gutters

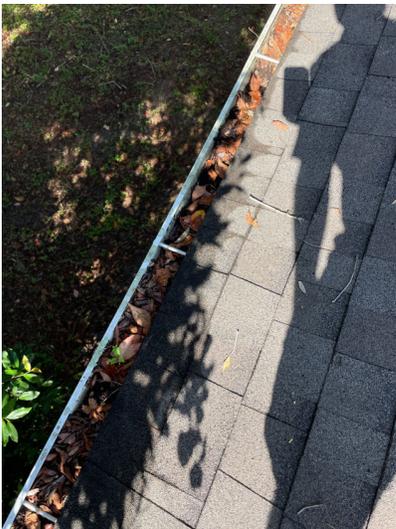
Heavy Debris Gutters

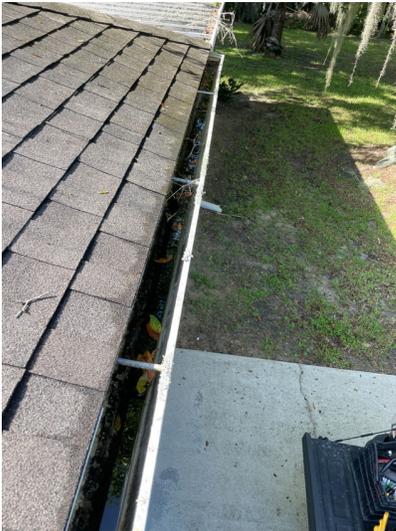
Water in Gutters - May Need to Be Re-leveled

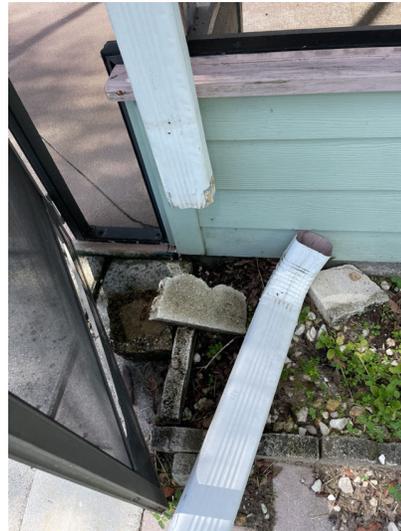
Detached Gutter Downspout

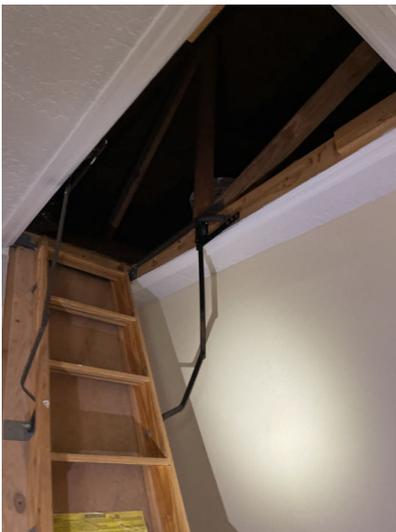
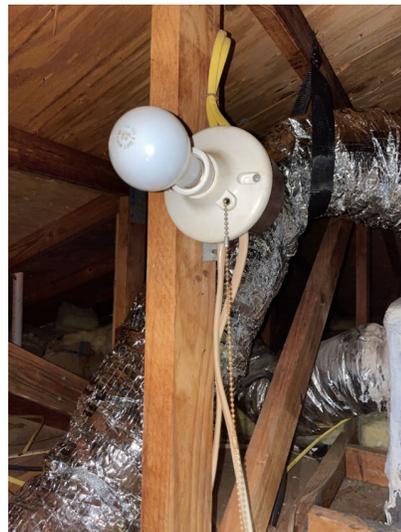
- Attic light located just inside access. Out.

Light Not Working

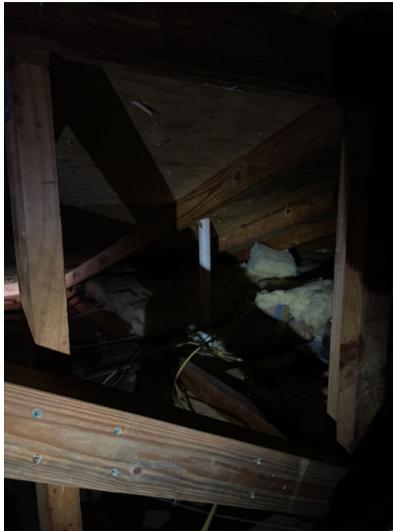
Depth of Insulation: Insulation averages 3 to 4 inches. Recommend installing more.

- Insulation appears to have settled significantly, which will not perform to its original R-Value. Expect higher energy loss and heating & cooling costs. Recommend an insulation contractor evaluate for replacement and/or addition.

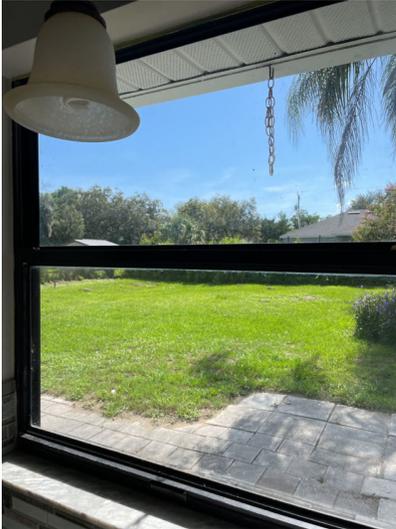
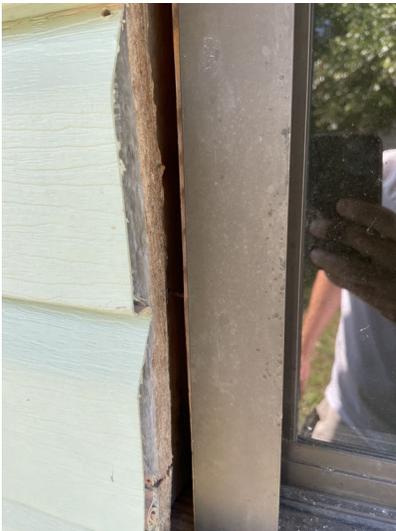
Possible Seal Broke in Window - Condensate

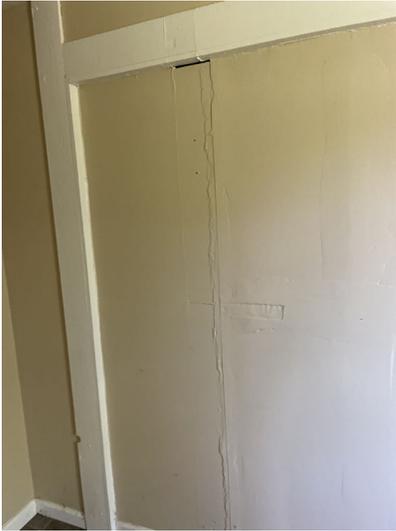
- Wall finish, paint and baseboards appeared to be in serviceable condition at time of inspection.
- Evidence of prior drywall repair. Recommend recoating by drywall professional.

Minor Drywall Damage

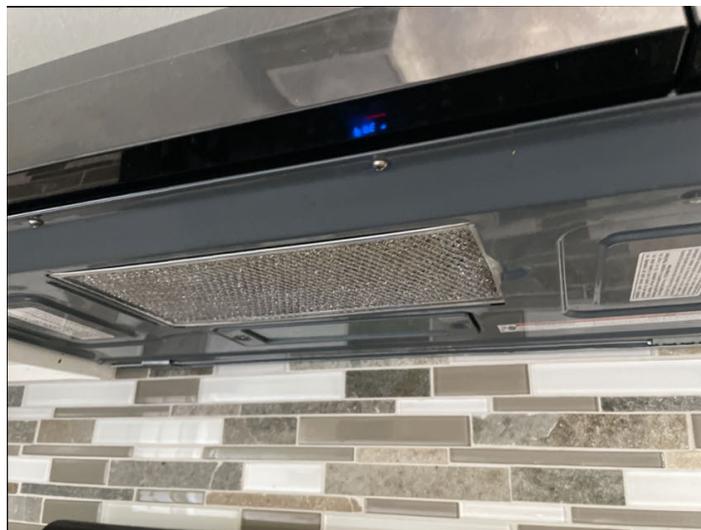
- The vent hood was operated on all speeds and appeared to function properly.
- Vent fan light is inoperable.

Hood Light Out

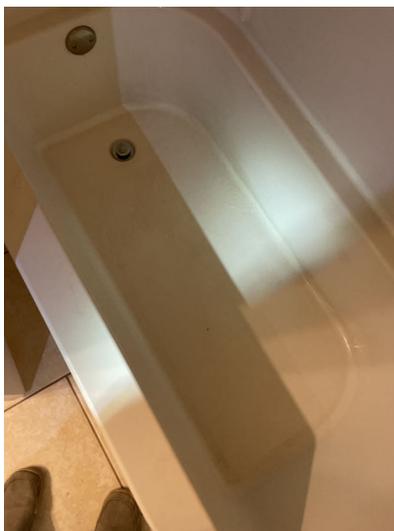
- Master bath features separate toilet closet. Toilet appeared to be in good visual condition and functioned when operated.

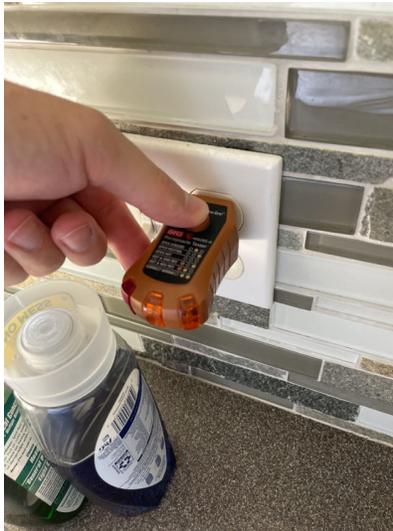
GFCI Tested - OK

- GFCI protection outlets in place and functioning properly at time of inspection.

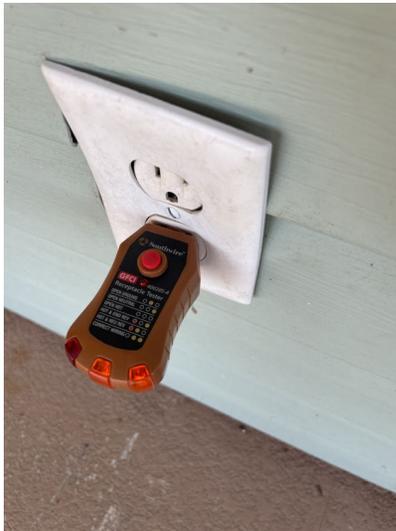
Loose Receptacle Outside

- No exterior electrical outlet issues noted at the time of inspection.
- Receptacle loose in box. Recommend repair for safety.

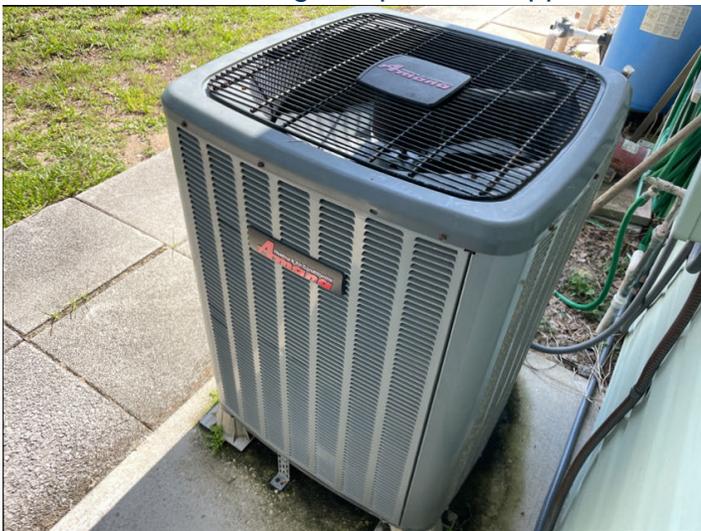
2015 Unit

AC Size/Brand/Year: 2.5 ton Amana AC Compressor manufactured in 2015 noted. These units typically have a lifespan of 15-20 years.

- The air conditioning compressors appeared functional at the time of inspection.

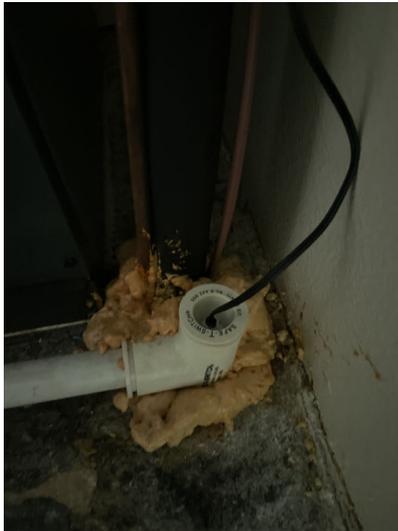
Split Test - OK

- Recommend adding insulation at A/C refrigerant lines to prevent condensation and energy loss.

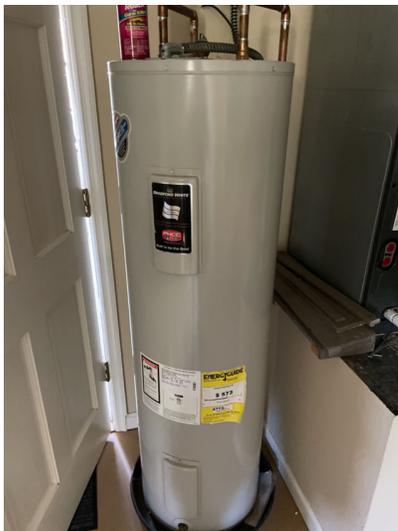
2012 Water Heater

- The heater is located in the addition area.
- 40 gallon tank water heater manufactured in 2012 was noted. Average lifespan of such units is typically 20-25 years.

- Water heater appears to be in satisfactory and functional condition at time of inspection.
